# Review and Response to the Summer 2007 Floods in the Cotswold District

## Second Phase Report

25 July 2008

Report no: 0002-NE02933-WXR-04

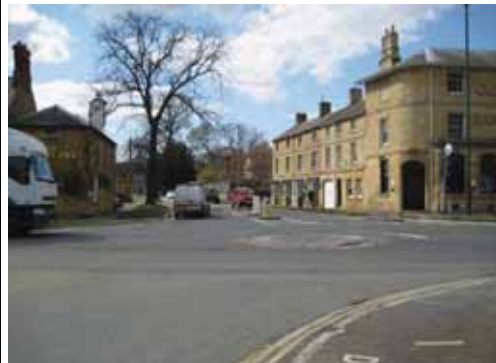
*Photograph – View of Bourton Road, across the High Street, from East Street*

Surface water run-off from Bourton-on-the-Hill is reported to have caused flooding problems in Moreton-In-Marsh for a number of decades. Ditches run along both the north and south side of Bourton Road (A44), before entering culverts near the junctions with Hospital Road and Swan Close (at **1** and **2**). The capacity of this drainage system has been overwhelmed on at least three occasions in the past ten years, with surface water flowing

from Bourton Road into the High Street and along East Street; residents of East Street have had door flood guards fitted for a number of years. On 20 July 2007, the flooding here was exacerbated by blockages in the culverts (the Parish Council received confirmation of this from GCC); the water exceeded a depth of 1 m, causing over £1 million worth of damage to St. David's Community Centre and Primary School (**3**; BBC, 2007).

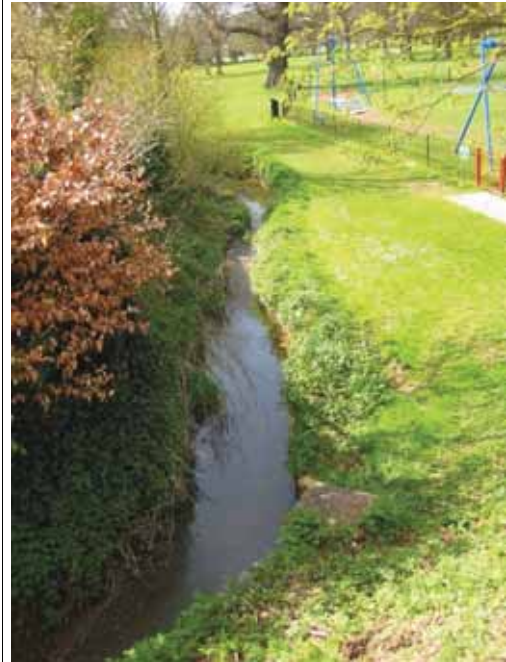
*Photograph - Existing trash screen on the inlet to the culvert in Queen Victoria’s Garden (12)*

Indeed, the Environment Agency has highlighted the culvert as a significant cause of the flooding in the town on 20 July 2007, noting in particular that the trash screen is inadequate and difficult to keep clear (van Beesten, 2008). A CCTV survey of the culvert, commissioned by the Environment Agency, was carried out (in part<sup>1</sup>) in December 2007. This showed that, after 40 m, the culvert splits into twin barrels and that tree branches and silt had collected at this split, restricting the capacity of the culvert. The Environment Agency has since cleared the culvert, and it is currently designing a new trash screen (van Beesten, 2008).

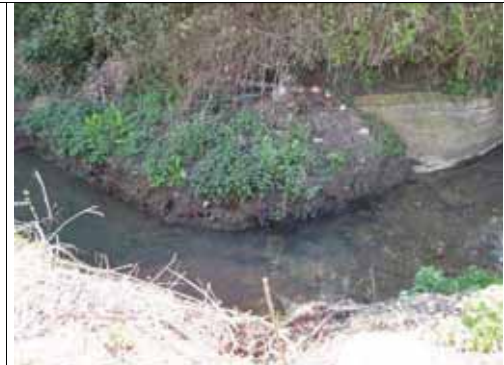
*Photograph – The right bank of the River Evenlode, downstream of the culvert from Queen Victoria's Garden (13). Soil has built up (or been placed) against the bank, narrowing the channel width*

downstream of the Oxford Street road bridge is heavily vegetated (20). In addition, the right bank at the outlet of the culvert from Queen Victoria's Garden (13) appears to have encroached upon the channel (see photograph above). A resident of Croft Holm has also noted that a fence, erected along the right bank of the Evenlode (21) by Thames Water, prevents maintenance access to the channel and bank. The Environment Agency has reported that, prior to the Summer 2007 floods, the River Evenlode was not included in its maintenance programme. However, it has re-assessed the situation and the river will now be cleared of blockages and trees as required. In particular, annual clearance of the river through Moreton-In-Marsh is programmed for late summer. However, it is important to note that maintenance is unlikely to have prevented the extreme flooding of Summer 2007 (refer to the main report).

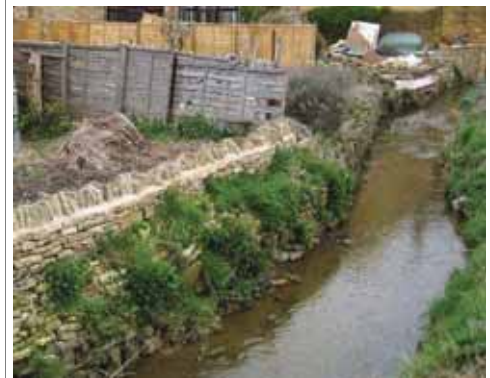
*Looking upstream at the town drain which takes runoff from Wessington Hill and issues next to the elf garage adjacent to the care home.*

The two land drains which flow through the town are not of sufficient capacity to convey flows during periods of high rainfall. A large proportion of the catchment to the north of the town drains into the Cam upstream of the new care home. The two town drains, which drain surface water from The Hoo and Westington Hill issue into a relatively short reach of the Cam. During high flows this results in a build up water in this section as the flows from the Cam and the two land drains converge. The level at which town drains enter the Cam is below the level of the river during high flow. Subsequently the water backs up through the town drains, exacerbating flooding.

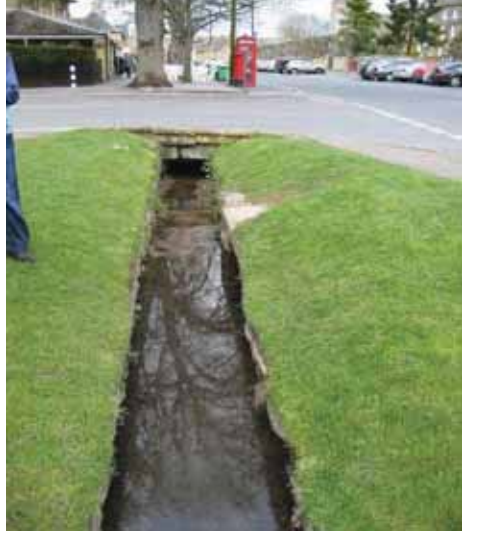
<p><i>Looking at the ditch which runs alongside the High Street through town.</i></p> <p>The ditch takes surface water drainage from the hills to the north of the village, the school fields and Moore Road. Surface water runs into the school playing fields, goes down the ditch onto the road and issues near the war memorial. The banks of the ditch are very low providing minimal freeboard above the water level and the top of bank. The ditch overtopped during the flooding resulting in water flowing onto the High Street.</p>

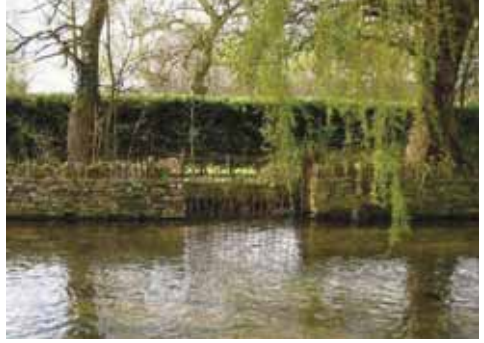
<p><i>Looking at the right bank of the River Windrush from High Street.</i></p> <p>The bricked up hole in the wall just downstream of Birdland prevented water from flowing through the field into the water meadows. This resulted in the loss of possible flood storage in the meadows and exacerbating the flooding on Rissington Road.</p>

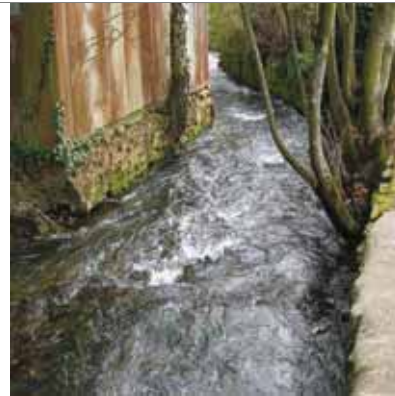
Birdland needs to ensure the trash screens are free of vegetation to allow the flow to get through the area. During the flooding grass from the catchment blocked the trash screen.

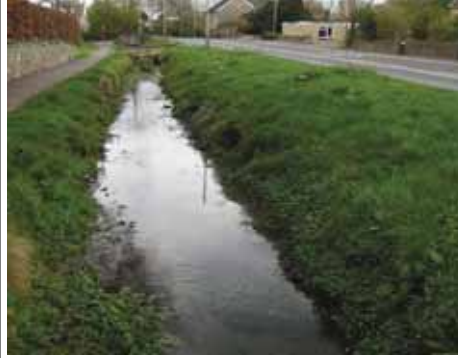
Description of Mechanism	Photograph
<p><i>Looking downstream of the Downington Ditch from the A417.</i></p> <p>Flows overtopping the ditch caused flooding in the July 2007 floods.</p>

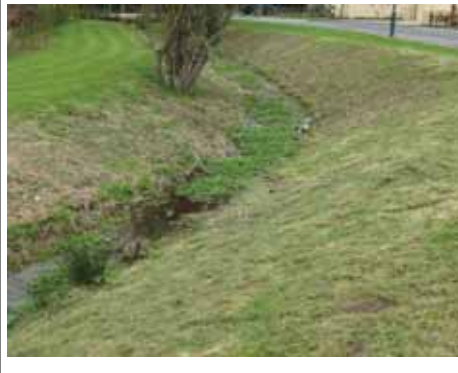
<p><i>A drainage ditch in the Butlers Close development.</i></p> <p>The development has a SUDS system which has not been maintained. The drainage ditches within the development are overgrown with vegetation and local residents reported infrequent inspection and maintenance of the ditches.</p> <p>The new development has gravel soakaways. Residents reported that during the flooding the soakaways caused water to drain onto the main road (A417).</p>

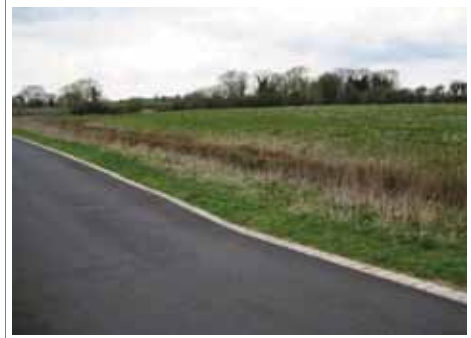
*Overgrown swale next to the access road from the A417 to the Butlers Close development.*

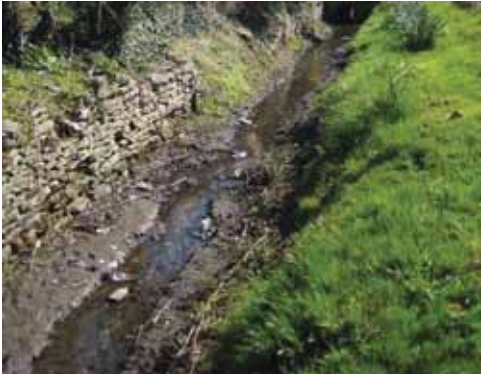
<p><i>Looking downstream at Court Brook.</i></p> <p>Moor Lane is low lying and at risk of flooding from Court Brook (channelled water course). The channel has insufficient capacity during high rainfall and during the July 2007 floods the brook caused extensive flooding on Moor Lane.</p>

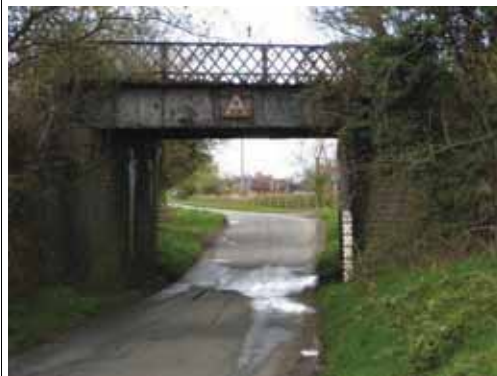
*Photograph – Railway bridge over Badsey Lane.  
Surface water run-off collects in this low spot (10)*

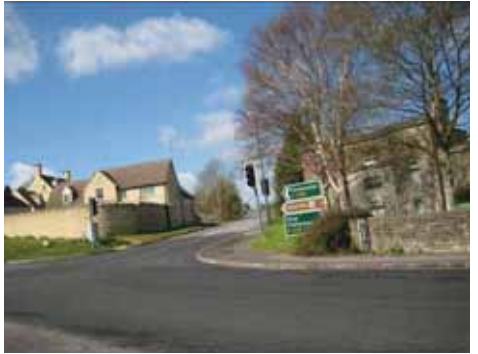
<p><i>The Cirencester Road (A429).</i></p> <p>The Cirencester Road floods regularly, as the road has very poor drainage, as a result the water flows directly into the town along the High Street. During the flooding surface water from the surrounding fields flowed down the road and into the town.</p> <p>There used to be open drains along the main road which ran through the town. Local opinion is since the drains have been filled flooding in the town has got worse.</p>

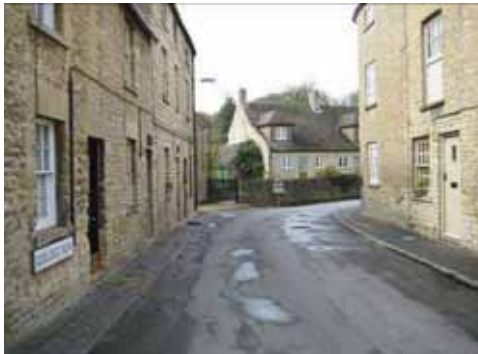
<p><i>The road level is the same height as the kerb on College Row.</i></p> <p>Road resurfacing has caused the road level to be raised to the height of the kerb along many roads throughout the town. The road drainage is poor and this results in the roads flooding on a regular basis. The height of the road in relation to the kerb resulted in water flowing directly into properties from the roads. The areas worst affected by this are Mill End, College Row and the High Street.</p>

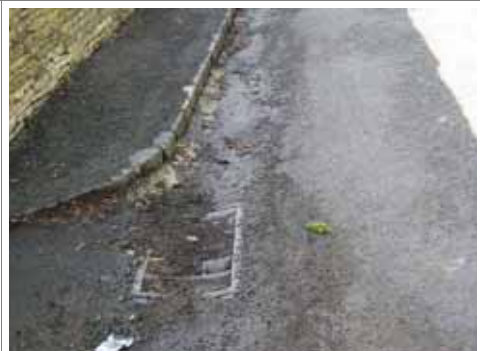
*Blocked drain at the bottom of School Hill.*

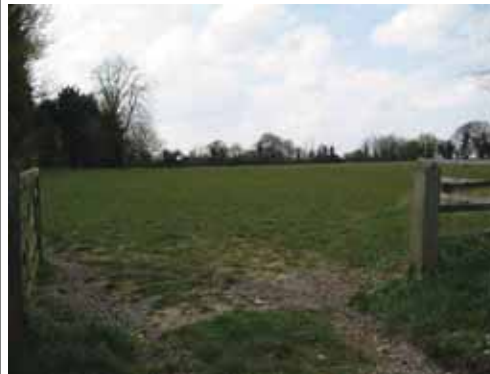
Blocked ditches were also a problem at the Standing Cross Lane Junction (6), where surface water run-off from Tiltup joined the Eastleach road. Following the Summer 2007 floods, villagers paid to have the road ditches cleared out. A trash screen at the Standing Cross Lane junction remains in a poor condition.
