# Review and Response to the Summer 2007 Floods in the Cotswold District

## Second Phase Report

25 July 2008

Report no: 0002-NE02933-WXR-04

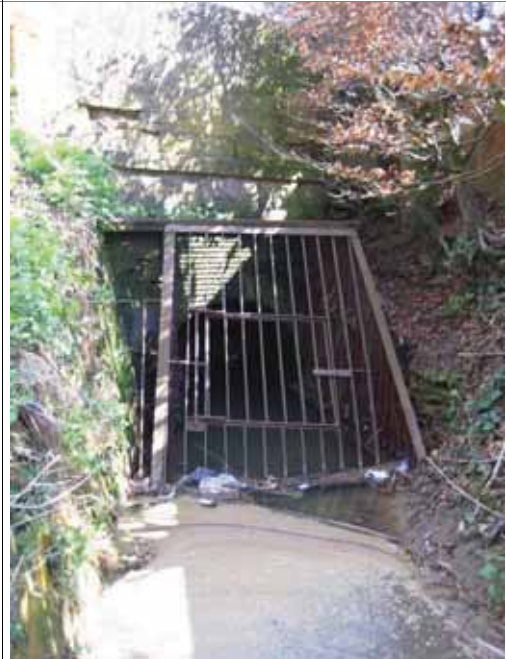
*Photograph – Downstream view of the flood relief ditch, from Stow Road*

A flood relief ditch was constructed in the 1960s to route water from the Bourton Road area to the south of the town, before discharging into the River Evenlode at point **16**. Twin culverts carry this ditch under the Stow Road (**17**) and the railway line (**18**). The culvert under the railway comprises a brick barrel cell, which is the responsibility of Network Rail, and a concrete cell, maintained by CDC. The backwater of this culvert flooded properties along Fosseway Avenue. Both Parish Councillors and local residents have reported that this culvert was partially blocked at the time of the flood. CDC has written to Network Rail regarding this; Network Rail's reply noted that the culvert was not blocked, but that work was required to the outfall. It is unclear whether this work has been undertaken.

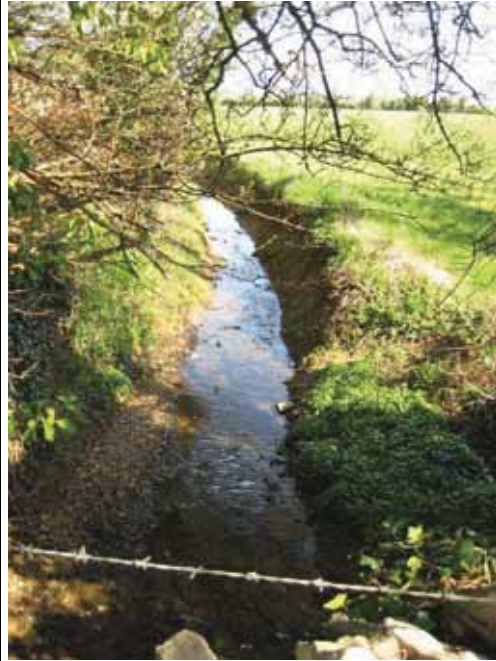
*Photograph – The right bank of the River Evenlode, downstream of the culvert from Queen Victoria's Garden (13). Soil has built up (or been placed) against the bank, narrowing the channel width*

downstream of the Oxford Street road bridge is heavily vegetated (20). In addition, the right bank at the outlet of the culvert from Queen Victoria's Garden (13) appears to have encroached upon the channel (see photograph above). A resident of Croft Holm has also noted that a fence, erected along the right bank of the Evenlode (21) by Thames Water, prevents maintenance access to the channel and bank. The Environment Agency has reported that, prior to the Summer 2007 floods, the River Evenlode was not included in its maintenance programme. However, it has re-assessed the situation and the river will now be cleared of blockages and trees as required. In particular, annual clearance of the river through Moreton-In-Marsh is programmed for late summer. However, it is important to note that maintenance is unlikely to have prevented the extreme flooding of Summer 2007 (refer to the main report).

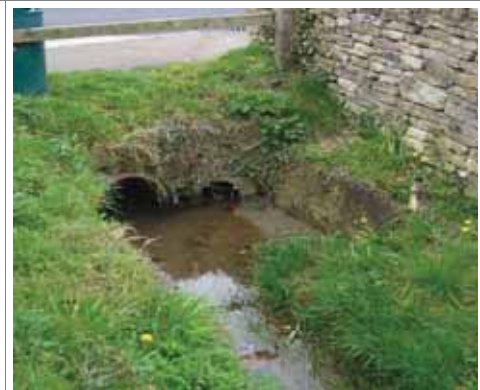
*Looking upstream at the town drain which takes runoff from Wessington Hill and issues next to the elf garage adjacent to the care home.*

The two land drains which flow through the town are not of sufficient capacity to convey flows during periods of high rainfall. A large proportion of the catchment to the north of the town drains into the Cam upstream of the new care home. The two town drains, which drain surface water from The Hoo and Westington Hill issue into a relatively short reach of the Cam. During high flows this results in a build up water in this section as the flows from the Cam and the two land drains converge. The level at which town drains enter the Cam is below the level of the river during high flow. Subsequently the water backs up through the town drains, exacerbating flooding.

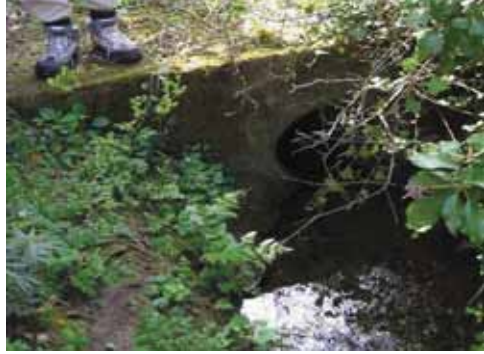
Description of Mechanism	Photograph
<p><i>Looking downstream at the CDC ditch culvert.</i></p> <p>CDC ditch (at Clapton Hill) runs from Clapton Hill Road, there is a restriction of the flow under the road in the form of a short culvert. The constriction results in water backing up through the ditch during high flow.</p>

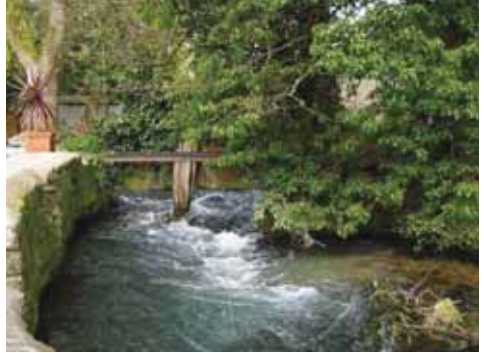
<p><i>Looking upstream at the redundant sluice from the Duke of Wellington car park.</i></p> <p>A redundant sluice gate at the rear of the old mill (presently the motor museum) was inoperable in the open position. The sluice gate restricted flow, causing river levels to back up, resulting in the flooding of the museum and properties upstream. Flood water flowed through the Manor House and onto High Street. The water then combined with water flowing down Sherbourne Street.</p>

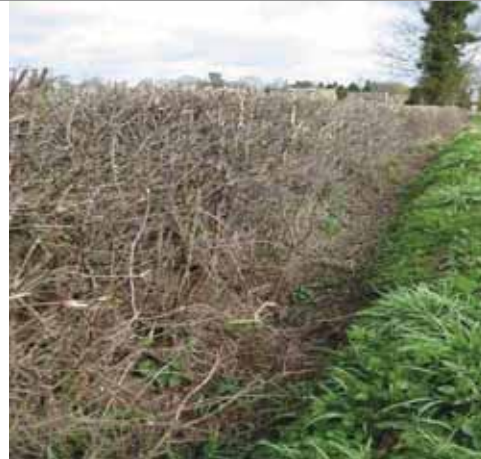
*Looking at a ditch in Bourton.*

During the flooding there were poorly maintained ditches throughout the town which were blocked by debris or obstructions which exacerbated the flooding. Overflowing drains were reported during the flooding.

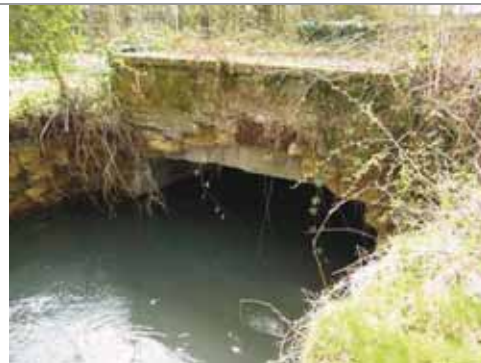
*Looking downstream of the River Dicker at the old road bridge.*

There is a pinch point where the water flows under the old road bridge. The bridge restricts the flow resulting in water backing up into the lakes (into Lake No1 then Lake No2).

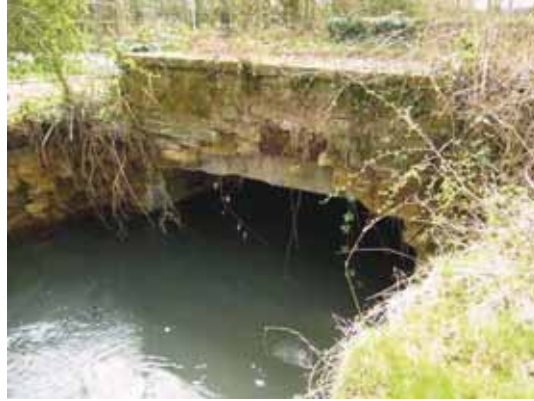
*Looking downstream of the River Dicker at the old road bridge.*

The old road bridge collapsed during the flooding. Some of the debris has been removed from the watercourse but there are still remnants of the bridge in the channel. It is recommended the channel is cleared of debris to ensure the channel is efficient as possible by limiting the obstructions to flow.

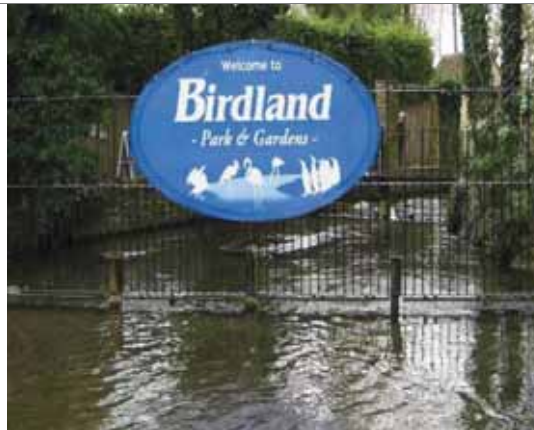
Birdland needs to ensure the trash screens are free of vegetation to allow the flow to get through the area. During the flooding grass from the catchment blocked the trash screen.

The EA have recommended the channels within Birdland can be improved by removal of obstructions and localised raising of the banks to ensure the river stays in its banks for longer. There is an option for the security screens to be replaced with screens which would minimise flow impediment without compromising security for the birds.

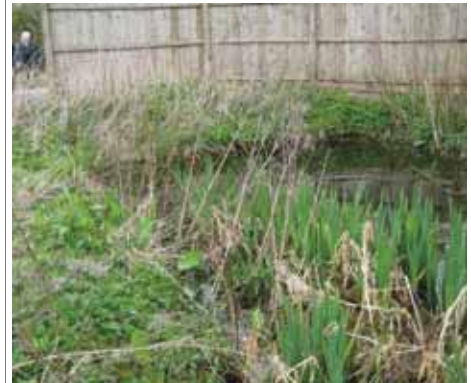
*Standing water from an unconnected pipe in the Butlers Court development.*

GCC have confirmed the surface water system in the development was not connected to the main surface water drainage in locations. This is resulting in uncontrolled discharge issuing onto the land.

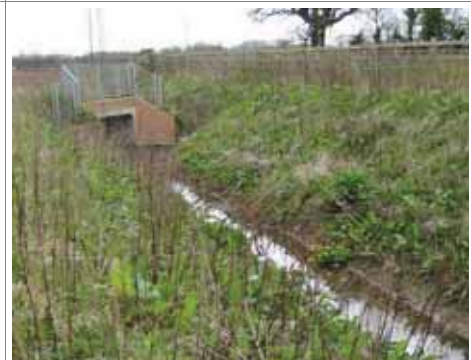
*Looking upstream of the ditch leading to culvert under the roundabout.*

When the new roundabout was constructed new culverts were installed under the roundabout. There were reports the flood relief ditch constructed by GCC to convey flows from the roundabout around the town during high flows was blocked during the flooding. Flood water flowed down the ditch alongside the main road and exacerbated flooding downstream.

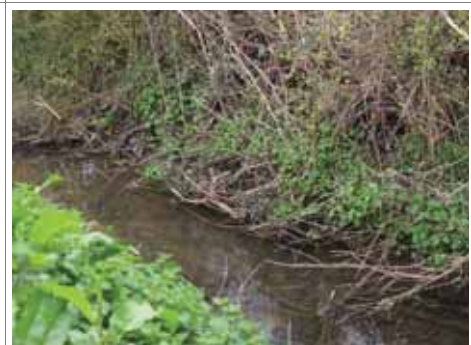
*The ditch which runs alongside the A417.*

The A417 road was flooded, past the garden centre to the veterinary surgery, as the drainage on the road was not functioning. The ditches were silted up, overgrown and as a result not functioning properly.

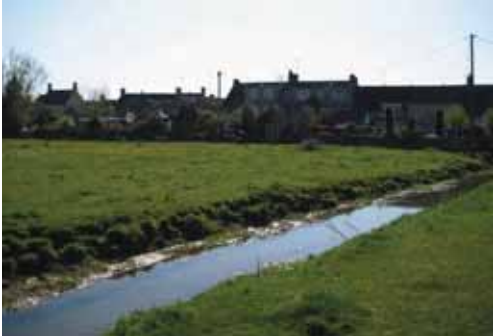
Description of mechanisms	Photograph
<p><i>Looking downstream at the Waterloo Brook- the houses in the background are the back of the houses on Milton Street.</i></p> <p>The Waterloo Water Meadows flooded as water spilled from the River Coln into the meadows. The flood waters flowed through the permeable dry stone wall to the back of the properties and flooded the properties on Milton Street.</p>

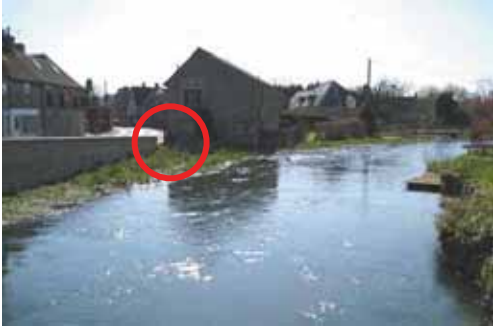
<p><i>Looking downstream at the River Coln from Milton Street Bridge</i></p> <p>The gap in the wall before the Bull Inn, allowed water to flow onto High Street during the flooding.</p>

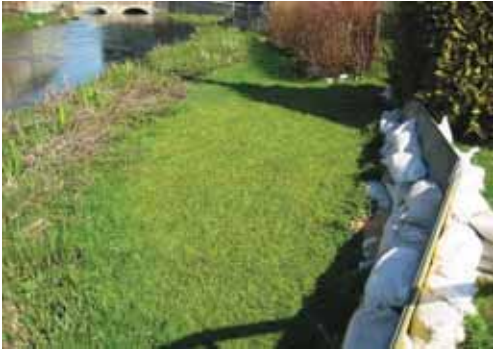
<p><i>Looking upstream at the River Coln and the left bank of the river from White Hart Court.</i></p> <p>The banks of the river are very low on each side, especially the left hand bank. White Hart Court flooded from fluvial flooding during the 2007 floods. White Hart Court flooded previously during the floods of 2000.</p>

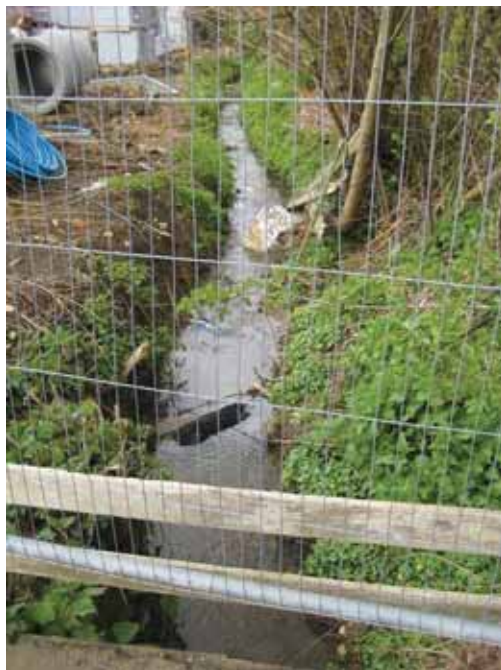
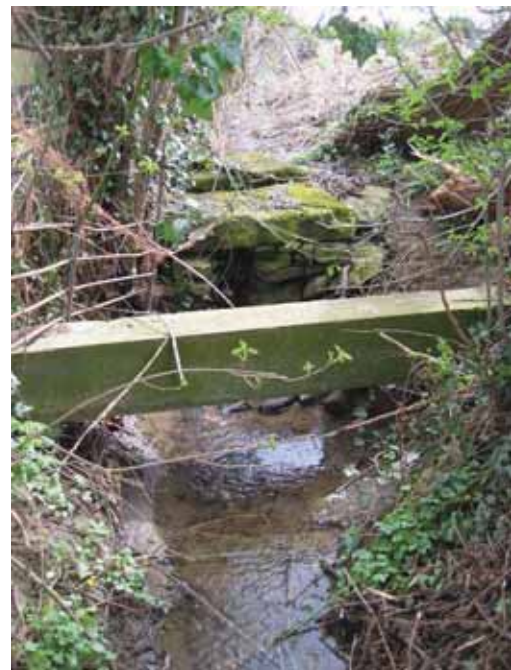
*Photographs – The watercourses in the vicinity of the new development (7)*

Five new houses are currently being constructed on land (occupied formerly by a motor caravan manufacturer) to the west of Timms Green (**7**). The Parish Council is concerned that this development will exacerbate the flooding problem. It is unclear whether the Planning Application for the development was supported by a Flood Risk Assessment, although the proposal submitted at the planning stage did include the opening up of an existing culvert.

Recommendation	
<b>A</b>	Ensure that the construction of the new development (7) includes appropriate mitigation measures to reduce the risk of flooding both to and from the site
<b>B</b>	Ensure that the un-named watercourse, which flows north-westwards through the village, is maintained and that the trash screens are inspected and cleared regularly
<b>C</b>	Examine the cause of the blockage that occurred to the south of Frampton Drive (5), and take any necessary remedial action
<b>D</b>	Undertake a condition survey of the culverts under Campden Lane and Broadway Road. Remove any blockages and make necessary repairs
<b>E</b>	Review the disposal method for debris removed from land drainage ditches
<b>F</b>	To reduce the risk of flooding to Timms Green, investigate the feasibility of creating a temporary flood storage area in the playing field (12) adjacent to the watercourse (this may require hydrological and hydraulic assessment of the watercourse)

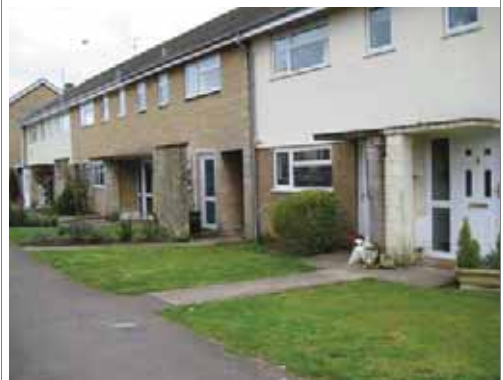
Drains are regularly overwhelmed on Countess Lillas Road. The area has a long history of surcharging resulting in flooding from surface and foul water. The soakaway in the field behind the road could be under capacity and need extending. The area has a very high water table and recently built developments have flooded from ground water flooding.

All drains on the road go to the soakaway located in the field behind the road. The area has a foul water flooding problem and flooded from foul and surface water during the 2007 floods. Due to the recent development in the area there are uncertainties regarding the connections into the soakaway.

<p><b>A</b></p>	<p>Melmore Gardens, Rose Way, Southmead Close, Countess Liliat Road and Alexander Drive require a drainage survey to be completed to assess the capacity of the drains. If the drainage is found to be inadequate, improvements should be made to the drainage network to reduce the risk of flooding.</p> <p>GCC has reported that a drainage pipe under Siddington Road has collapsed in sections and is of insufficient capacity. The poor condition of the pipe is contributing to flooding to the east and west of the road. This requires investigation by Thames Water.</p>
<p><b>B</b></p>	<p>As a short term measure all of the drains in the areas affected by flooding should be regularly inspected and maintained on a regular basis.</p>
<p><b>C</b></p>	<p>The soakaway located in the field behind Countess Liliat Road should be investigated to check the connections into the soakaway and to determine if the capacity of the soakaway needs increasing.</p>

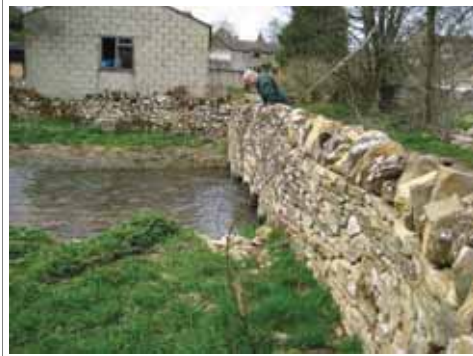
*Looking at the Dovecote Bridge from the road.*

The bridge has 3 small orifices which hold back water during high flows on the Dovecote floodplain. If the capacity of the floodplain is exceeded, in previous events, water has flowed through a gate by the bridge and joined the river downstream of the bridge. During the flooding the gate was blocked by grass which had recently been cut and water could not rejoin the river downstream. Subsequently the river flowed over the left bank onto the main road and flooded properties.

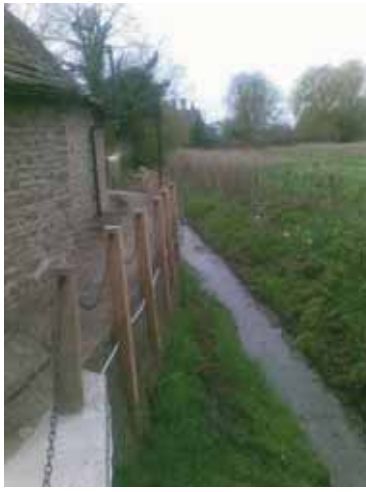
Description of Mechanism	Photograph
<p><i>Photo looking west and upstream from upstream of the road culvert.</i></p> <p>This ditch overtopped the banks and flooded seven surrounding properties. Ditch upstream is generally clear.</p>

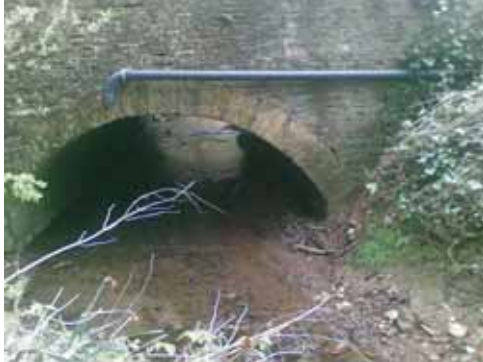
<p><i>Looking downstream from the road bridge.</i></p> <p>Ditch is generally clear downstream, however banks tend to be overgrown and difficult to access in some locations. The ditch makes several right angle turns before being allowed to meander towards Ampney Brook. Fences that cross the ditch are also thought to catch debris and impede flows during storm events<sup>1</sup>.</p>

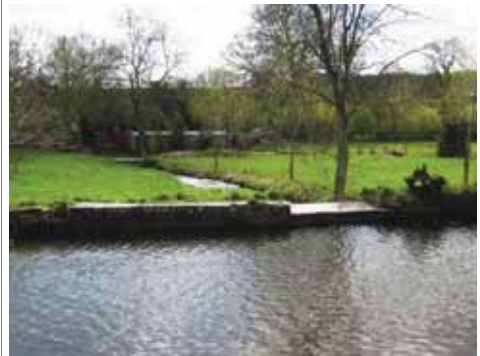
*Looking upstream at the confluence of the mill pond and the River Eye (mill at centre of photo).*

The water discharging from the mill pond enters the River Eye at this point. During high flows, water from the pond hits the outside wall of the cottage (shown to the right) and in July contributed to flooding not only this cottage but adjacent properties.

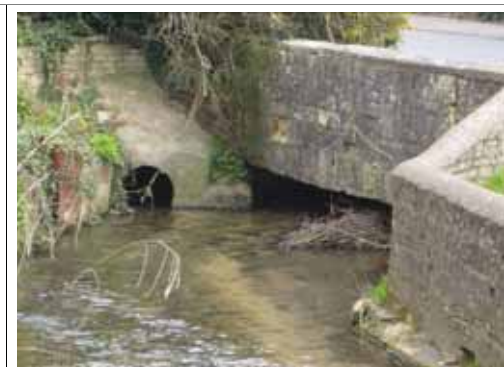
*Photograph – River Coln: downstream face of Station Road bridge (2)*

The River Coln flows in a general southerly direction through Andoversford. It is culverted beneath the premises of the agricultural machinery business (1) and Station Road. Surface water discharging from a side road onto the northern section of station road almost flooded properties on Station Road (2); the capacity of the Station Road culvert appears relatively small. Limited

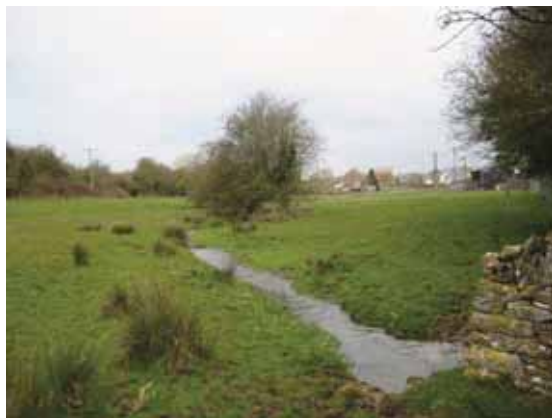
*Photograph –View of right bank tributary, looking north-west towards the embankment. Water built up in this field before spilling into the village centre*

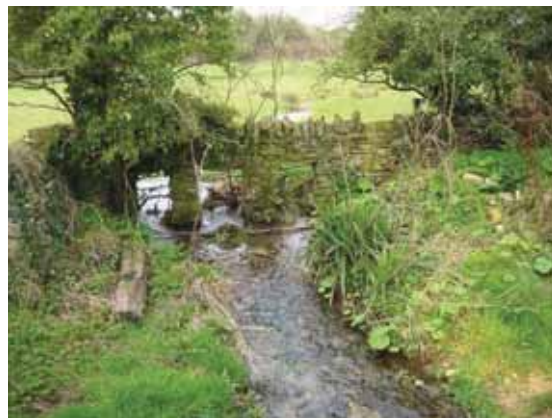
*Photograph – Stone structure across the watercourse (10). This structure is reported to be boarded up at times to prevent livestock escaping*

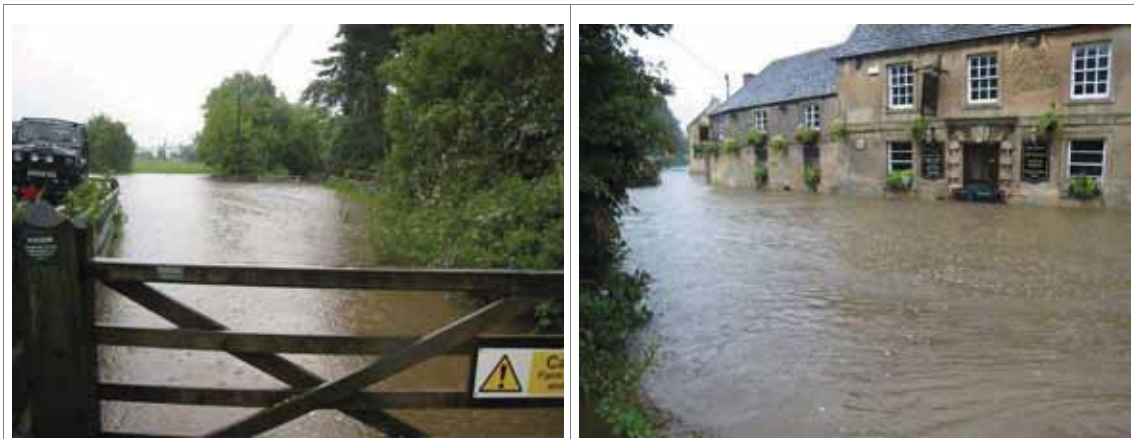
*Photograph –20 July 2007: water flowing towards the field gate (6)*

*Photograph – 20 July 2007: Flooding along Gloucester Road (7)*

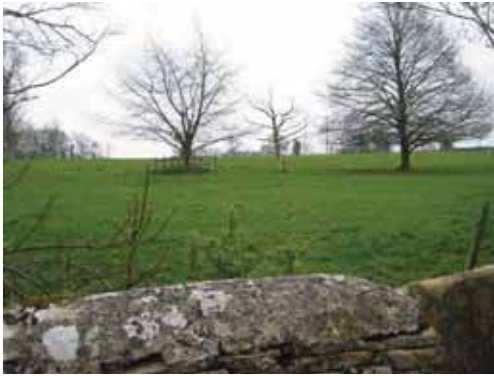
<b>Description of Mechanism</b>	
Surface water run-off	
<p><i>Photograph – View of the Furlongs field, looking east</i></p> <p>Surface water runs off of the Furlongs field regularly (1). The landowner (The Ernest Cook Trust) installed a French drain and soakaway along the western edge of the field around 15 years ago. However, this drainage system was ineffective on 20 July 2007.</p> <p>The villagers reported that the Furlongs field has not been ploughed for many years. This is likely to have increased surface water run-off.</p>

<b>F</b>	Clarify the design of the drainage system in Furlongs field, including capacity, condition and discharge point
<b>G</b>	Calculate the peak flow rate and volume of surface water run-off from the Furlongs field, for a range of return periods. This will inform recommendation I.
<b>H</b>	Investigate the feasibility of improving the formal drainage of the Furlongs field. Consideration should be given to the discharge point; in particular, assess whether the drain(s) could discharge to the Barnsley Drain.

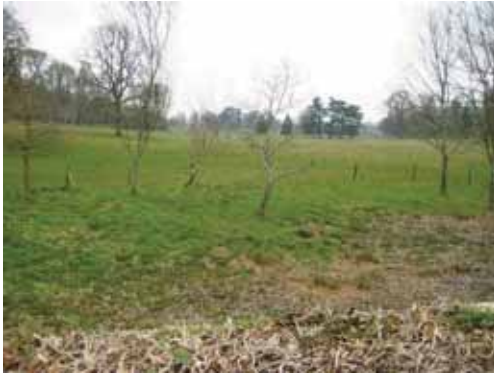
<p><i>Photograph – View of Barnsley Park, looking north from the B4425</i></p> <p>Barnsley Park is an eighteenth century landscaped estate, covering an area of 160 ha (UKPG, 2002). The topography of the Park slopes downwards to the south and the B4425; the land is lowest adjacent to the road bend and surface water run-off collects here frequently (2). A 150 mm diameter drainage pipe runs in a north-south direction under the Park and the B4425, and into Furlongs field (Skarda, 2008). A sump/soakaway in the Park is reported to drain surface water into this pipe as well as an ancient culvert, known locally as the 'Barnsley Drain'.</p>

<p>On 20 July 2007, surface water spilled out from Barnsley Park (either by overtopping the Park's boundary wall or via a hole in the wall caused by a previous car accident) and onto the B4425. The road is reported to have flooded to a depth of 0.3-0.45 m (le Bars, 2007). The water then flowed south along the B4425 into the village, as well as into the Furlongs field, augmenting the run-off from the field itself. Reports indicate that flow passed through the dry stone wall and filled the Furlong field within 40 minutes.</p> <p>Villagers suggest that the build up of water in Barnsley Park on 20 July 2007 was the result of a blockage, since water usually drains away without causing any flooding problems in the village (as occurred on 13 January 2008 following heavy rainfall).</p> <p>The villagers have also reported that surface water collects on the road bend itself and has caused accidents.</p> <p>Gloucestershire County Council note that a letter has been sent to Barnsley Park and The Ernest Cook Trust requesting a meeting with their representatives, to discuss whether routine maintenance or other further measures on their estate land can be taken to prevent future flooding problems in the village (Galland, 2008).</p>

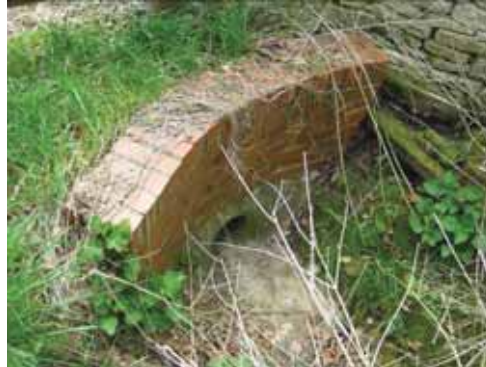
*Photograph – Inlet to the culvert that carries a land drainage ditch under The Farriers (4)*

The Farriers estate (1) was flooded by surface water run-off from fields immediately to the north of the village (2). A land drainage ditch runs south-eastwards along a field boundary (3); this ditch is heavily vegetated. It enters a culvert at 4, which runs under the estate. The estate is reported to have been flooded once a year on average since it was built nine years ago, indicating that the capacity of the culvert is inadequate. Following heavy rainfall, the culvert is overtopped and manhole covers on the estate are lifted due to surcharging. Overland flow is reported to enter the foul sewer system.

Mitigation Recommendations	
<b>A</b>	Calculate the peak flow rate and volume of surface water run-off from the fields to the north of The Farriers and The Forge, for a range of return periods
<b>B</b>	Use these calculations to assess the adequacy of the existing culverts under The Farriers and The Forge
<b>C</b>	Investigate the feasibility of resizing the culvert under The Farriers
<b>D</b>	Assess the adequacy of land drainage in the catchment as a whole, and investigate opportunities for improving both the natural and formal drainage (refer to the main report)
<b>E</b>	Assess whether the design and operation of the Hydro-Brake is appropriate, taking account of the Environment Agency's requirements for controlling surface water run-off. If the installation is deemed appropriate, clarify maintenance responsibilities for the Hydro-Brake and formulate a maintenance programme (if this has not been done already)

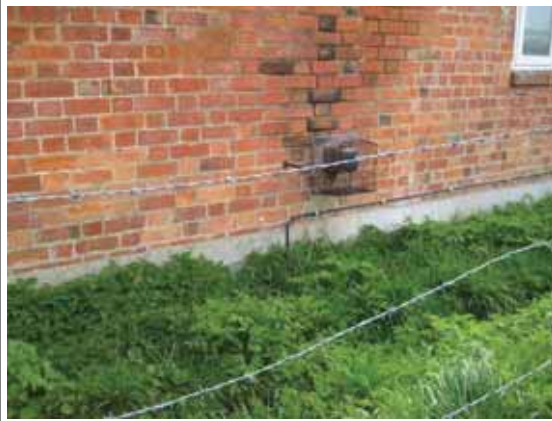
Blocked ditches were also a problem at the Standing Cross Lane Junction (6), where surface water run-off from Tiltup joined the Eastleach road. Following the Summer 2007 floods, villagers paid to have the road ditches cleared out. A trash screen at the Standing Cross Lane junction remains in a poor condition.

*Photograph – Partially blocked entrance to a culvert at the Standing Cross Lane junction*

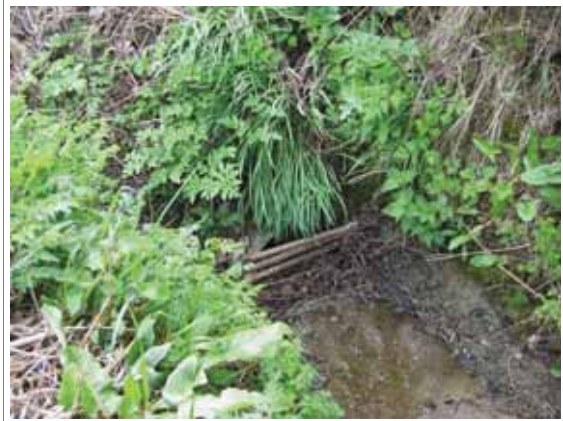
*Photograph – The roadside ditch immediately north of The Forge (7). This ditch has been cleared since the Summer 2007 floods*

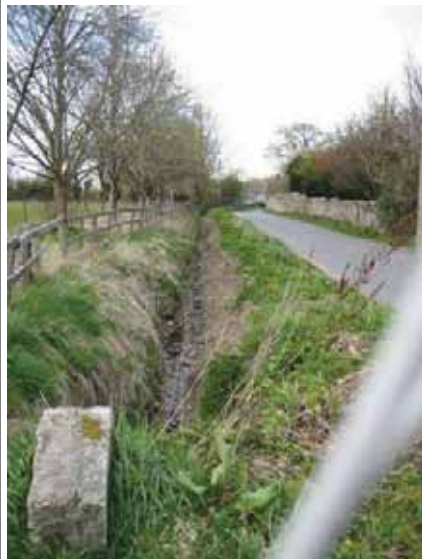
*Photograph – A roadside ditch at the Standing Cross Lane junction (6). This ditch has been cleared since the Summer 2007 floods*

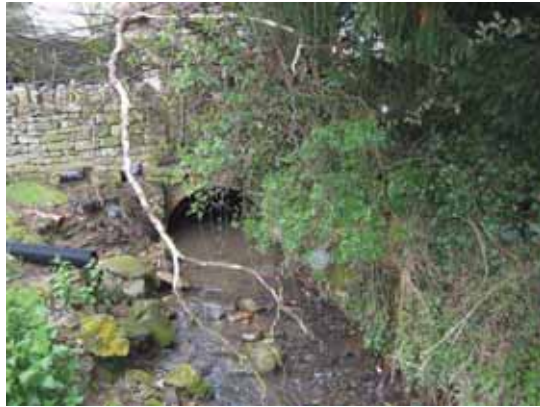
*Zone 4 – Upstream face of the Coombe Brook culvert under Friday Street (9)*

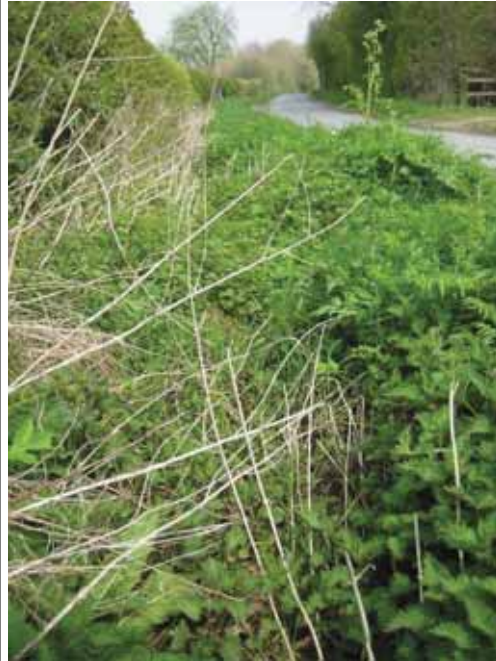
The Parish Council has met with the land owner and Gloucestershire Highways to discuss the state of the ditch along the Fyfield road (3; photograph). Many of the ditches in the village are reported to be in a similar condition. The Ernest Cook Trust has cleared the ditch in the vicinity of 4, but there is believed to be a blockage in the culvert under the road.

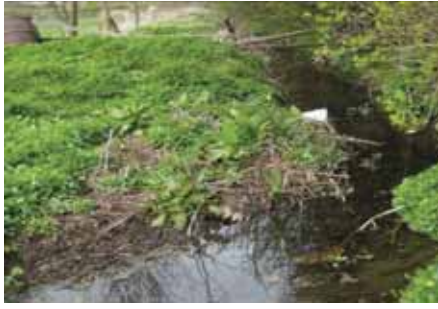
Description of Mechanism	Photograph
<p><i>Looking at the drainage ditch near the Post Office.</i></p> <p>The ditch is overgrown with vegetation and there are obstructions to flow in the ditch throughout the village. During the flooding this caused water to back up in the ditch through the village, resulting in flooding to properties in proximity to the ditch.</p>

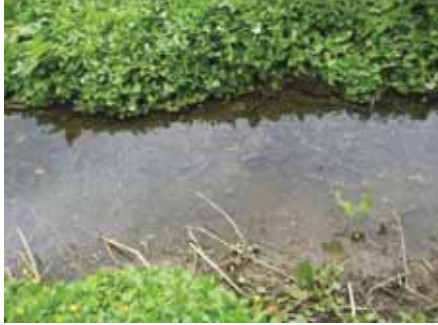
<p><i>Looking down at the drainage ditch from a field near the Post Office.</i></p> <p>Deposition of debris and silt has caused the ditches capacity to be reduced. Local residents report the drainage ditches were larger in the past to a depth of approximately 5 feet. There were reports that the maintenance of the ditch has been poor over the years and this has resulted in the gradual deposition of material. The drain was overwhelmed during the flooding.</p>

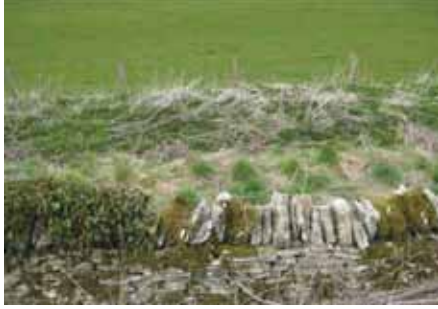
<p><i>Looking at the drainage ditch as it runs behind the wall alongside the B4425.</i></p> <p>The drainage ditch is barely visible due to the overgrown vegetation within and around the channel.</p>

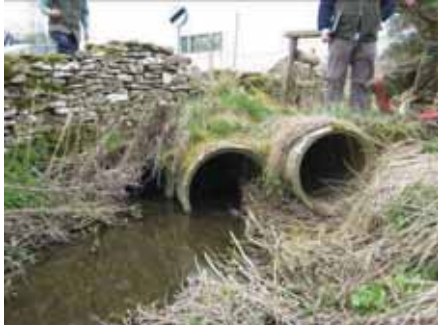
<p><i>Looking downstream at the culverts under the B4425 at the drainage ditch.</i></p> <p>Water in the ditch is not flowing through the culverts, which indicates a blockage. There are reports that the culverts were blocked during the flooding, resulting in flooding of properties upstream as water could flow out of the village through the culverts.</p>

Mitigation	
<b>A</b>	<p>Clear the culverts of any blockages to remove the impediment to flow and inspect and maintain culverts on a regular basis to ensure the culverts are free of debris.</p> <p>The blocked culverts have been highlighted to GCC and they are going to inspect and clear the culverts. Regular inspection of the structure should be added to GCC's works list.</p>
<b>B</b>	<p>Assess the capacity of culverts under the road and consider the need for new culverts if the existing proves to be of insufficient capacity or not functional.</p>
<b>C</b>	<p>The drainage ditch needs depending and clearing to allow water to flow out of the village through the culverts and into the field downstream of the B4425. Re-profiling of the ditch downstream of the culverts should be investigated, to avoid drowning of the culvert outfall. The sequencing of the clearance needs to be carefully coordinated and clearance of the ditch is not recommended until the issue with the culverts has been resolved.</p>

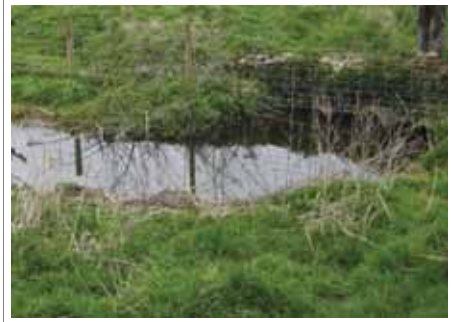
*Looking upstream at the culverts as they issue into the field by the B4425.*

The water level is higher at the downstream end of the culverts, indicating a possible design fault in the culverts. The ponding of the water in front of the culverts may indicate the ditch requires re-profiling through the field.

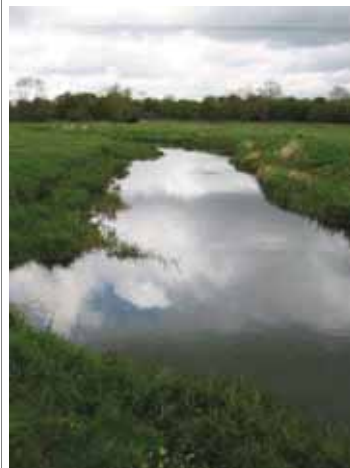
Adjacent fields (left, right and photo location) were inundated subsequent to the river overtopping its banks. The area is very flat with shallow river bed gradients. Once this area reaches capacity backwater effects are conveyed upstream which prevents the main river from the village from discharging.

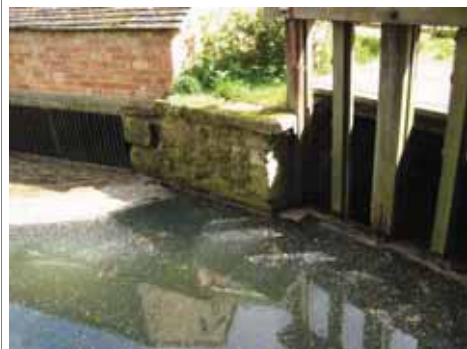
*At the Mill downstream from the confluence of the Bledington Brook and the Evenlode. Looking north-east towards the grated culverts under the road (B4450).*

Typically of Mill systems, two culverts flow underneath the mill building while one culvert diverts the flow away from the mill when not in operation. Residents in the village believe that the mill constrains the flow and prevents the Evenlode from draining adequately therefore contributing to the backwater effects in the village. The penstocks look to be operational however it is unknown whether it is controlled during storm events.

During July 2007 hay and straw was washed from the catchment and was caught against the grates.
